PERFORMANCE OF AUTOMOTIVE WHEEL BEARING GREASES

FINAL REPORT

SKF INDUSTRIES, INC. REPORT NO. AL78T022

U. S. ARMY MOBILITY EQUIPMENT
RESEARCH AND DEVELOPMENT COMMAND
FORT BELVOIR, VIRGINIA

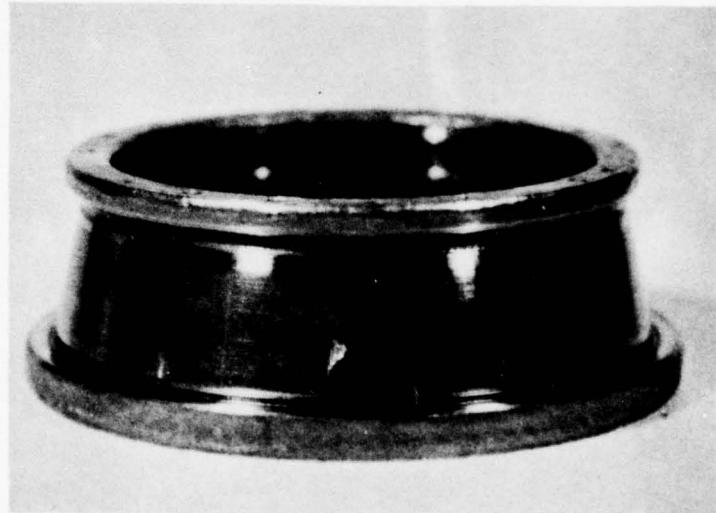
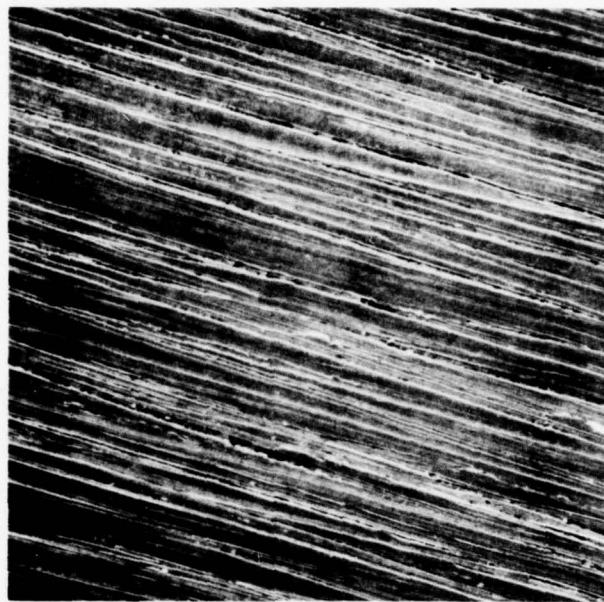
Figure 8 - Examples of Visible Damage to Cone Rolling Contact Surfaces

The degree of microwear occurring on a new bearing surface can be qualitatively estimated by comparing the SEM micrographs of the run surface with the new surface. Generally, if many lines remain the microwear is considered minimal or slight. As the wear process progresses, the lines become less distinct; but as long as some lines are evident the microwear can be considered as being within acceptable limits. When the lines are obliterated, the wear may be significant, and the internal geometry detrimentally altered. A microspalled surface will eventually generate the exfoliation of larger areas which will ultimately result in the total failure of the bearing surface as shown in Figure 8.

Cone Surface - Macrosurface Distress
Bearing No. 305B

Cone Surface - Spall and
Macrosurface Distress
Bearing No. 308B

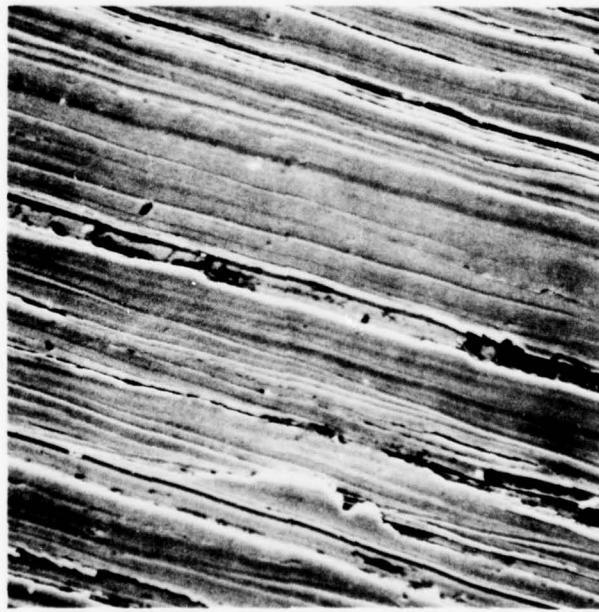
Figure 9 - Rolling Contact Surface of New Cone

Figure 9 shows SEM micrographs of the rolling contact surfaces of a new cone at 250X and 1000X. The micrographs depict the morphological aspect of a ground and honed surface according to current manufacturing practice. The majority of the marks or lines are those produced during the grinding process. The high asperities normally associated with a ground surface have been removed by honing. Superimposed lines running at a slight angle to the grinding lines are those produced by honing. Although at this high magnification, the surfaces appear rough, in reality, the roughness is less than 8 micro-inches A.A.

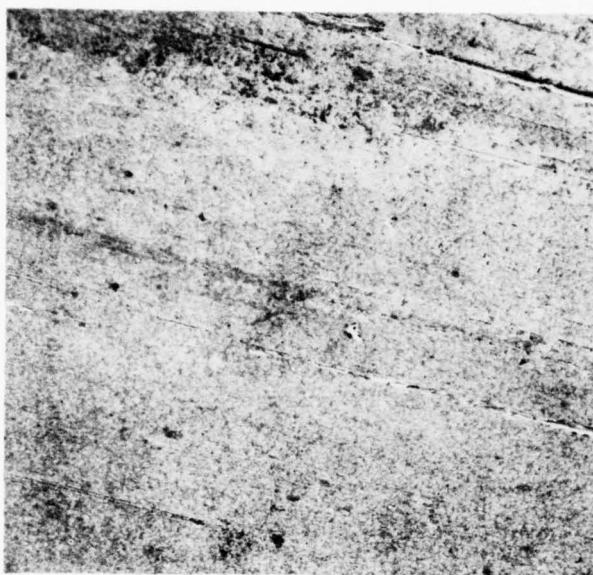
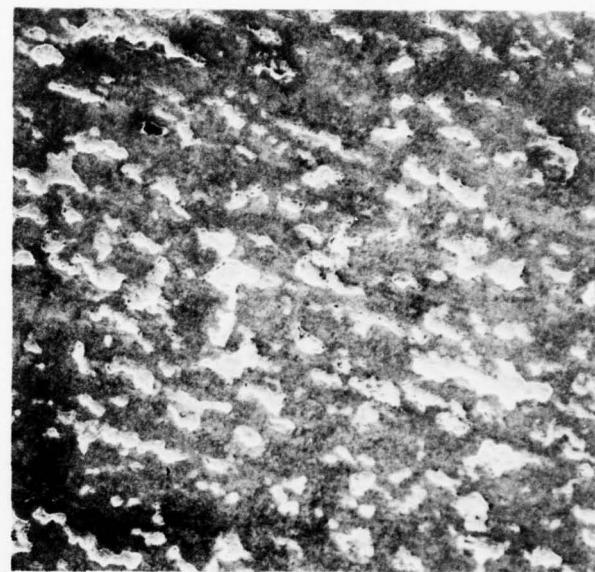
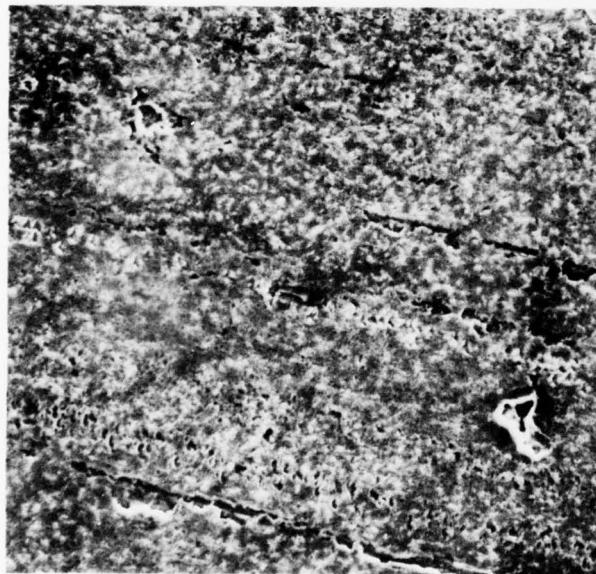
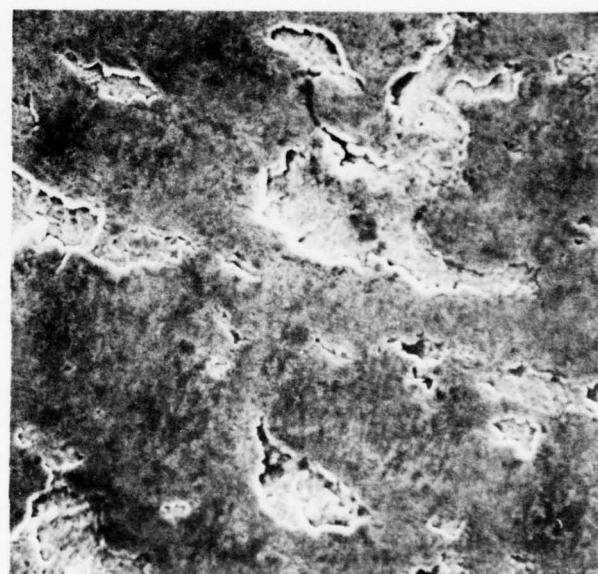
FIGURE 14. POST TEST CONDITION OF TEST BEARINGS.

Figures 14 to 17 show the rolling contacts of cone surfaces lubricated with Grease B. As indicated, very few of the grinding lines remain, and in some instances, none remain after approximately 100 hours operation. The surface damage observed virtually duplicates that previously noted with Grease A. Most surfaces are microspalled. Some macrospalls are visible without magnification. The rolling contacts are moderately to heavily worn and are extensively glazed.

The surface damage observed supports that previously noted on the other bearings in Group 2; and it is apparent that the condition has been caused by inadequate lubrication.

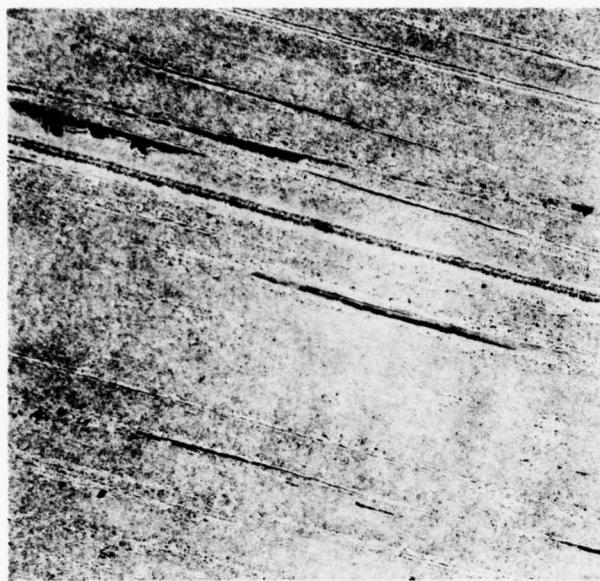
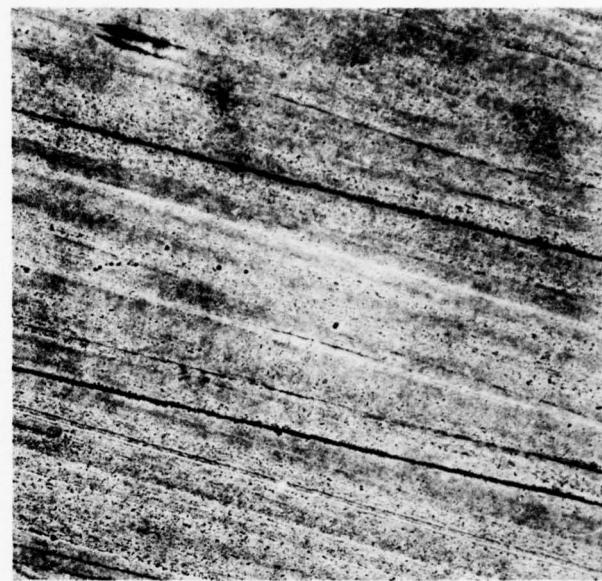
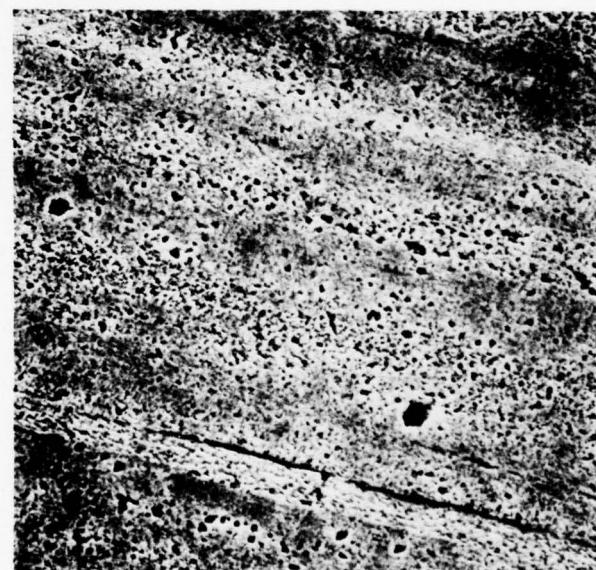
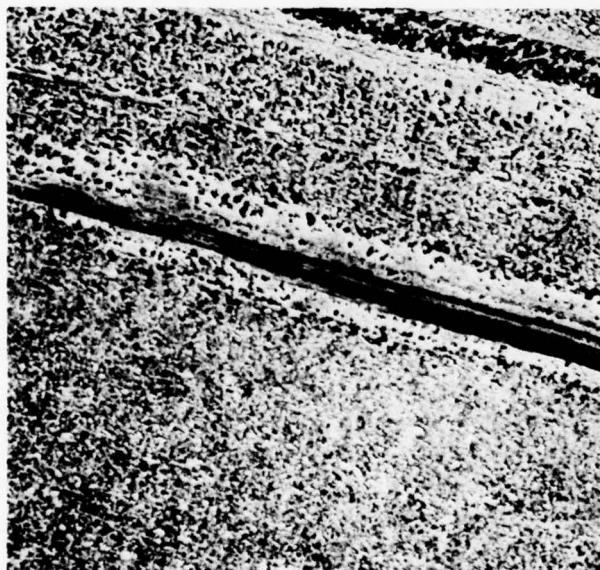
FIGURE 18. POST TEST CONDITION OF TEST BEARINGS.

Figures 18 to 24 depict typical examples of cone surfaces lubricated with Grease C. Except for Bearing No. 305B, Figure 20 which ran 167 hours, these bearings completed approximately 100 hours of operation. A few grinding lines are still evident, thereby indicating that a moderate amount of wear has occurred. The surfaces are severely microspalled; and macro-spalls are visible in some areas. Glazing is light to moderate.

The condition of these four bearings duplicates that observed in the remaining bearings of Group 3. The damaged surfaces are characteristic of those which have operated with deficient lubrication.

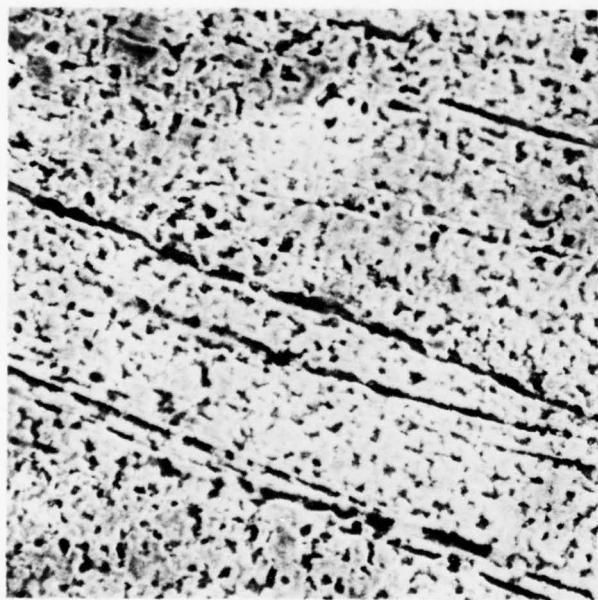
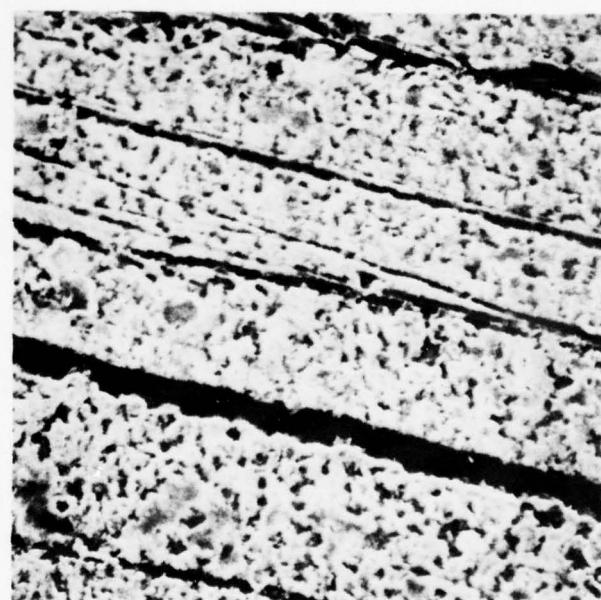
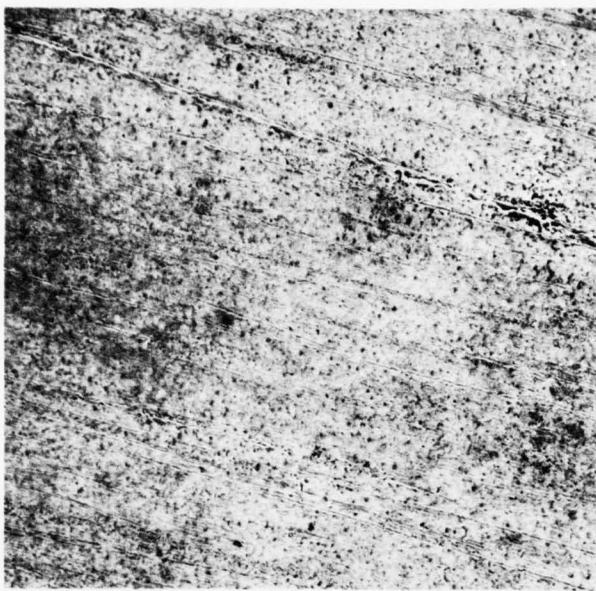
FIGURE 22. POST TEST CONDITION OF TEST BEARINGS.

Figures 22 to 25 show micrographs of cone surfaces lubricated with Grease D after 300 hours of operation. More grinding lines are evident indicating that the wear is light to moderate. In general, the surfaces are extensively micro-spalled or perhaps micropitted from some corrosive agent. Some macrospalls occur in a localized area of Bearing No. 420B, Figure 19. All bearings are slightly to moderately glazed.

The surface damage observed is considered as being much less than that previously noted with Greases A, B, and C especially when one considers the time differential i.e., 100 hours as compared to 300 hours of operation.

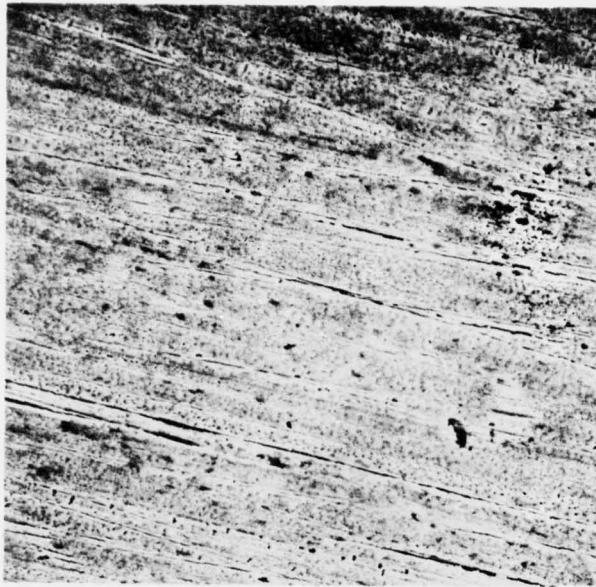
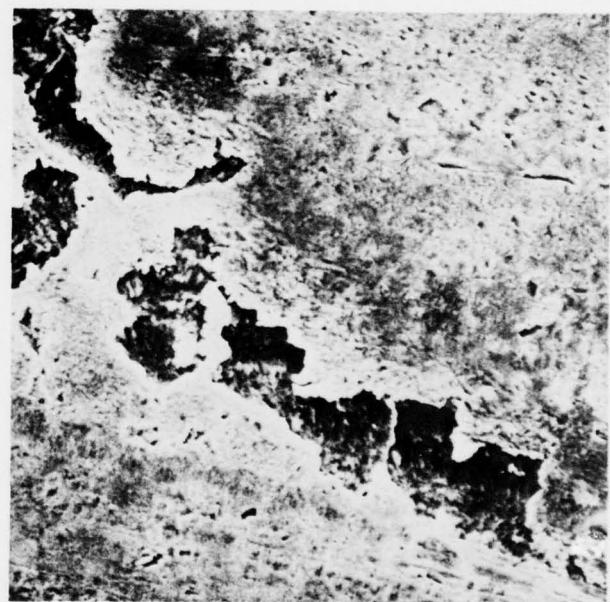
FIGURE 26. POST TEST CONDITION OF TEST BEARINGS.

Figures 26 to 29 exemplify the condition of bearings lubricated with Grease E. These bearings are representative of the group which had successfully completed 300 hours of operation. According to the micrographs, many of the grinding lines remain, attesting to a minimally degree of wear. The surfaces of these bearings appear to be microdented extensively as the result of rolling over microdebris. Some of these dents, in fact, have a triangular shape as shown in Figures 27 and 28. Figure 26 shows a localized area of Bearing No. 504A to be partly macrospalled, which was rare in this particular group of bearings.

The condition of this bearing sample is representative of the excellent condition noted previously for the group of bearings in general, and is indicative of good lubrication practice.

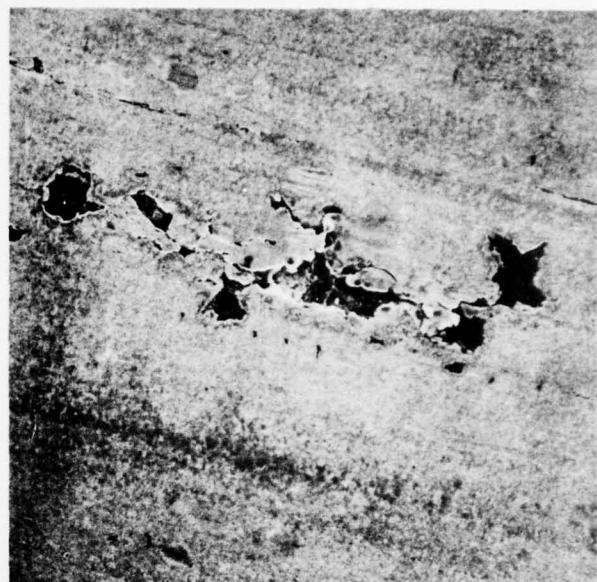
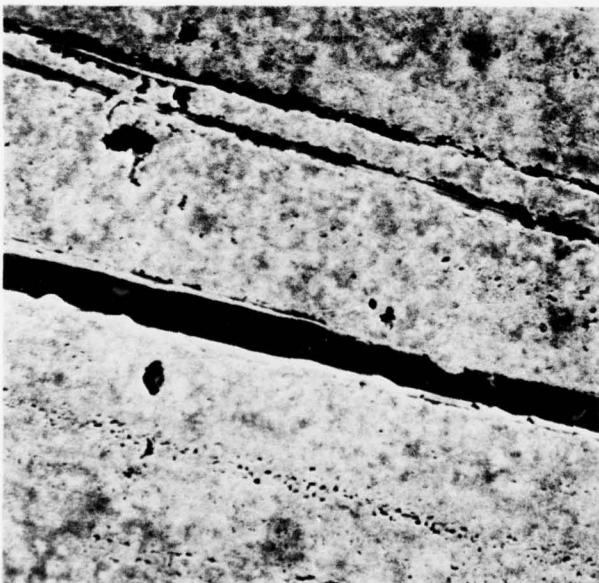
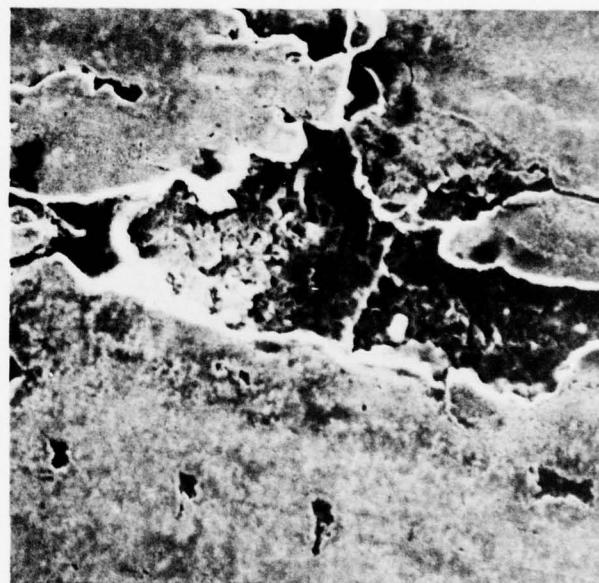
FIGURE 30. POST TEST CONDITION OF TEST BEARINGS.

Figures 30 to 33 show the surfaces of cones lubricated with Grease F after 300 hours of operation. The micrographs show that some grinding lines remain indicating only light wear. This is in contrast to Greases A and B which except for oil viscosity are similar in their chemical characteristics. It will be recalled that considerable wear occurred with Greases A and B after only 100 hours of operation.

The surface distress with Grease F ranges from micro to macro (barely visible) spalling, with a moderate degree of glazing. The lubrication characteristics of Grease F appear to be significantly better than Greases A and B, and about equivalent to Grease C.

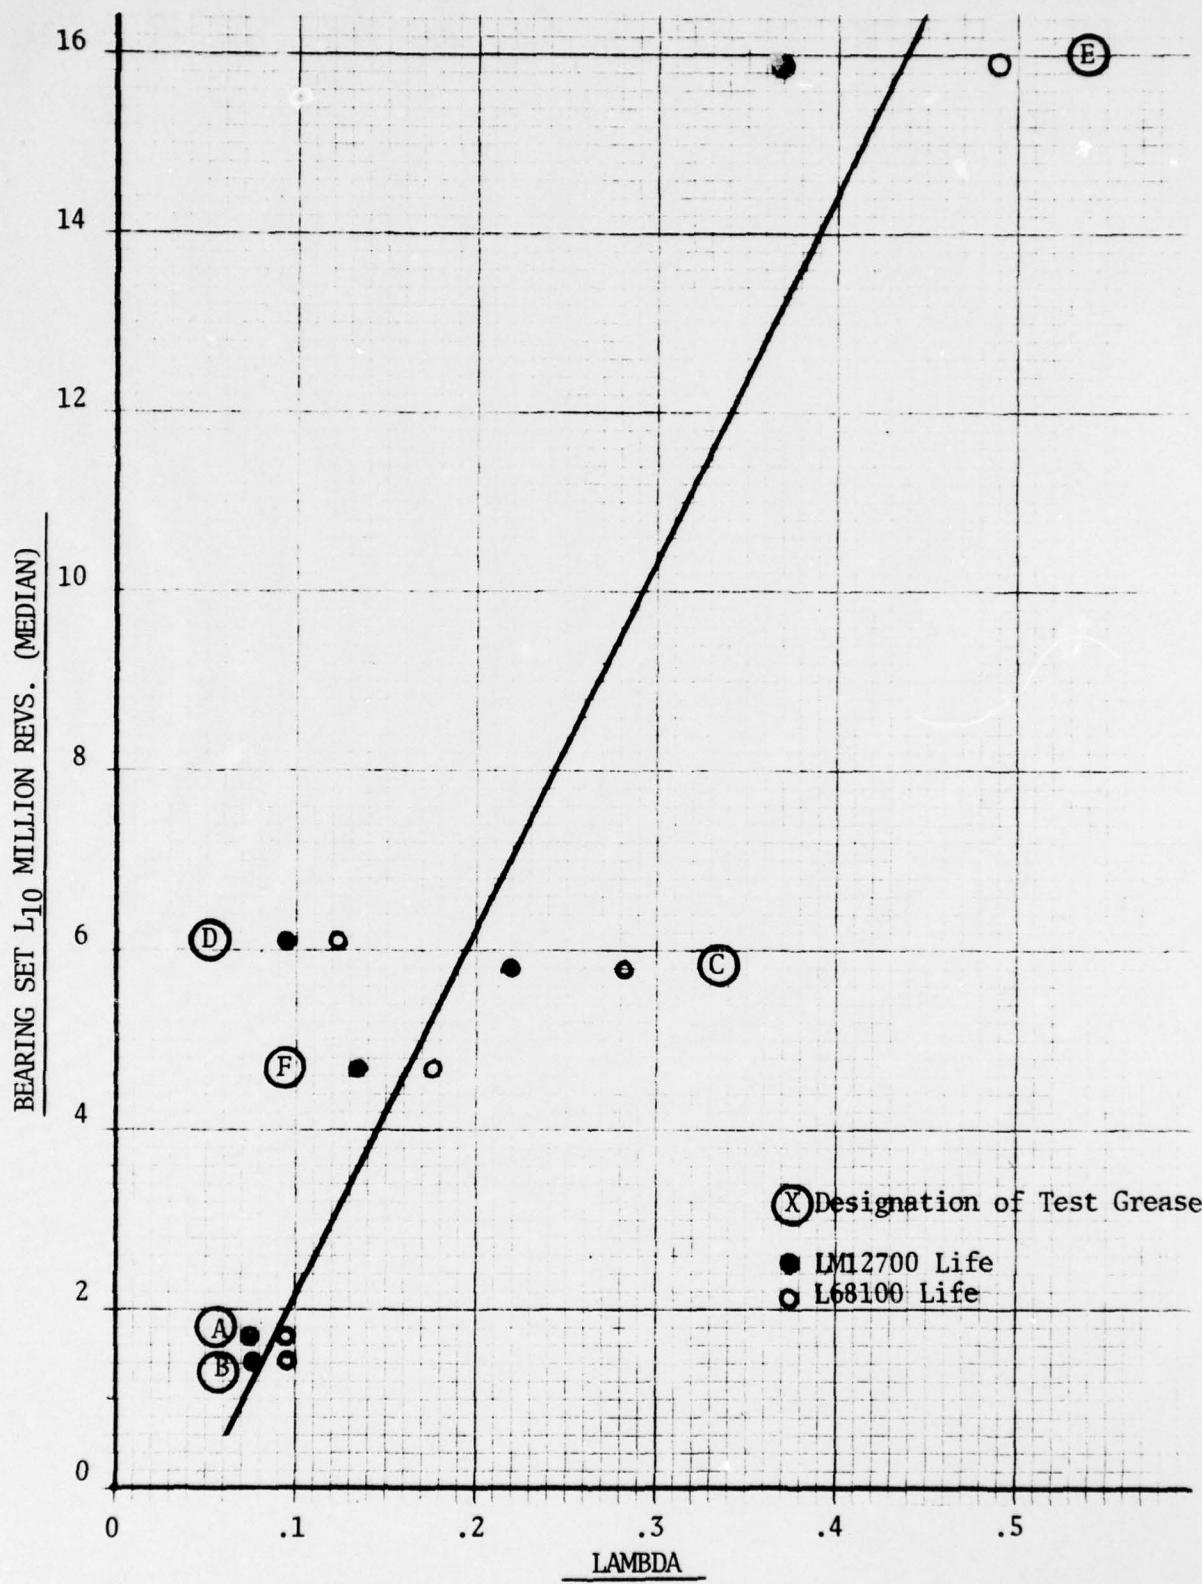
FIGURE 35. Bearing Life as a Function of the Elasto-hydrodynamic Film Parameter

Despite the extremely thin oil films available on the basis of the viscosity of the oil employed at the operating temperature run, a plot of the Lambda values against the median L_{10} life, Figure 35 indicates that there is a viable relationship between these two factors. Accordingly, those greases having a relatively higher viscosity, hence Lambda value, also have a proportionally higher life.

Grease F provided a higher life than A or B, probably as the result of having a 50% thicker oil film, which also accounts for its higher EP value according to the Four Ball Extreme Pressure Index Value noted in Table XVII.

Using the same hypothesis, the superiority of Grease E, a lithium product with a paraffinic oil stock, is explained by its higher oil viscosity and EP characteristics. The bearings lubricated with Grease E were the highest lived ($L_{10} = 15.97$ mil. revs.) which correlates with the highest Lambda and EP values of the greases evaluated. In addition, Grease E had the lowest wear rate indications as observed from the SEM micrographs. This grease is intended for high temperature use, i.e., 623°K (350°F).
